FLOOD PLAIN INFORMATION

YELLOWSTONE RIVER

LIVINGSTON MONTANA

PREPARED FOR
PARK COUNTY
AND
MONTANA DEPARTMENT OF NATURAL RESOURCES
BY
DEPARTMENT OF THE ARMY - OMAHA DISTRICT - CORPS OF ENGINEERS.68102
NOVEMBER 1974

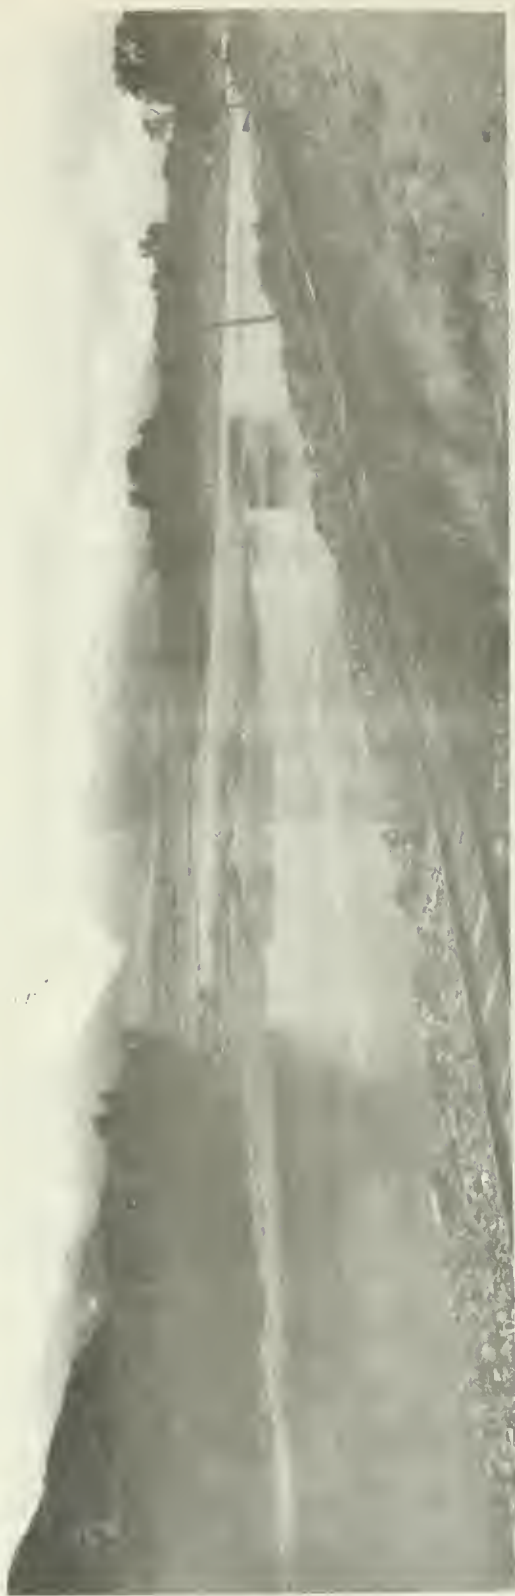
Figure 1. Looking upstream from 500 feet downstream of reference point 3. September 1974.

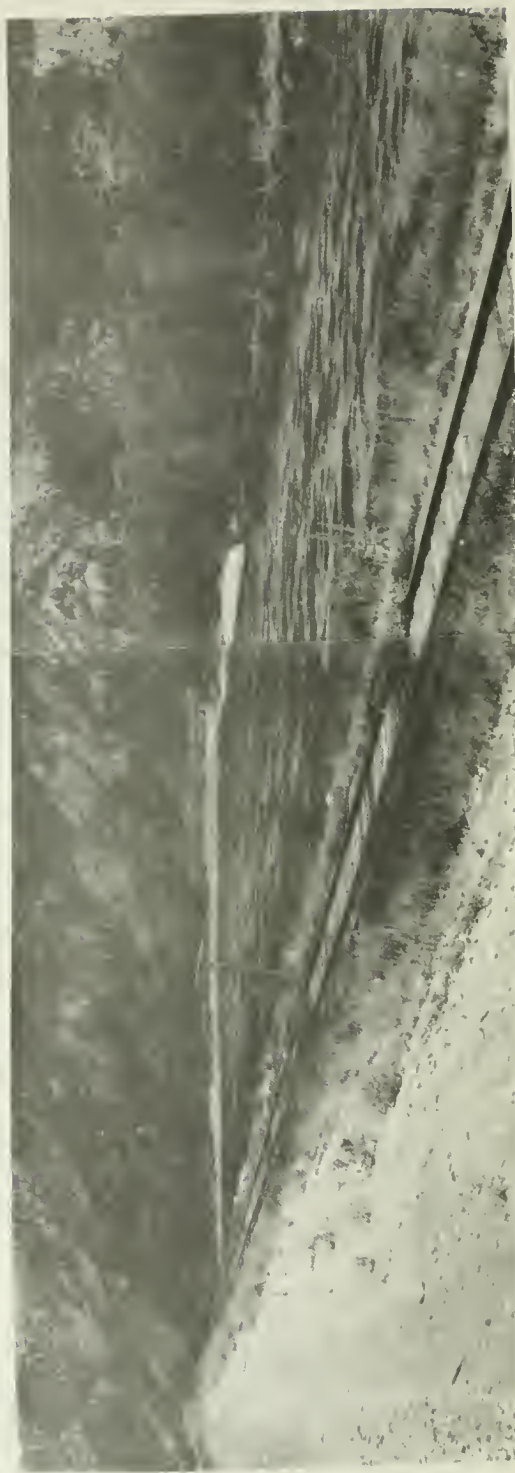
Figure 2. Looking downstream from 500 feet downstream of reference point 3. September 1974.

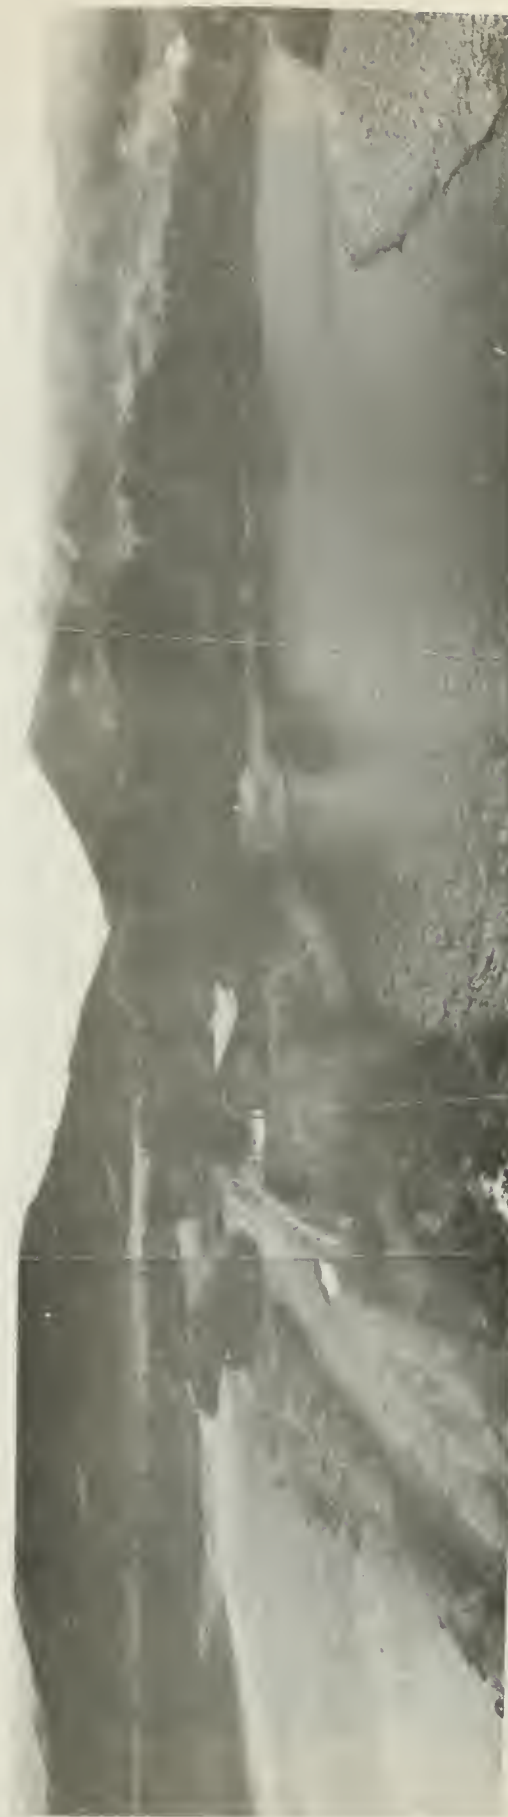
Figure 4. Looking upstream from the Interstate 90 bridge (reference point 13) at Siebeck Island. September 1974.

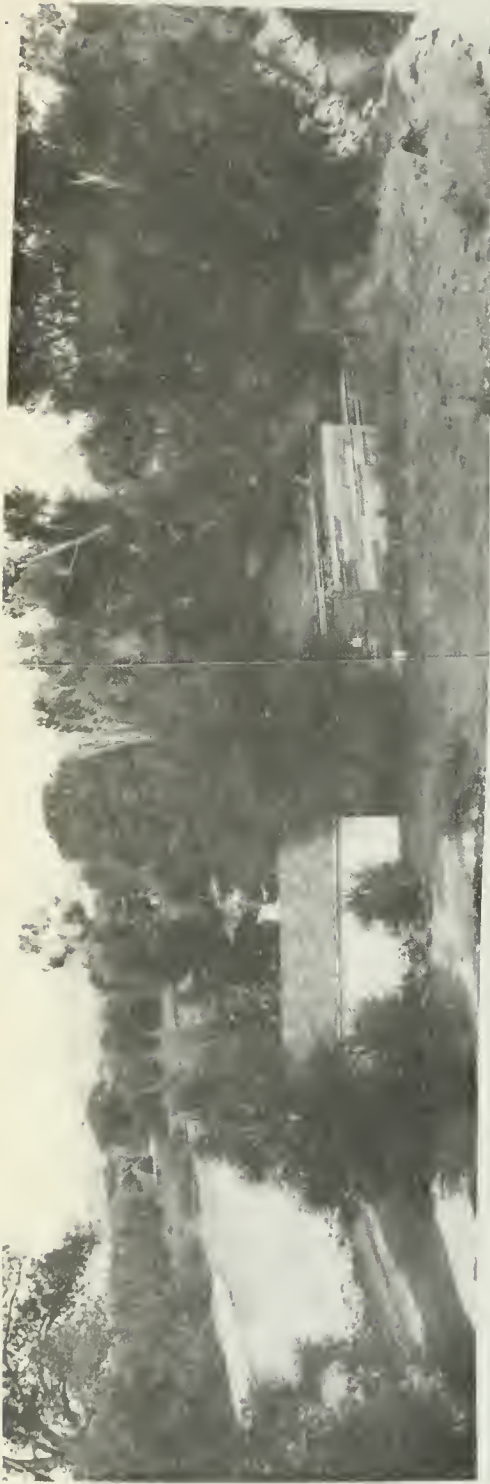
Figure 5. Looking downstream from the Interstate 90 Bridge (reference point 13) at Ninth Street Island. September 1974. Note what appears to be sandbags adjacent to the white building evidently remaining from the flood of June 1974. Note also that the right edge of Figure 5 blends with the left edge of Figure 6 making one continuous photograph.

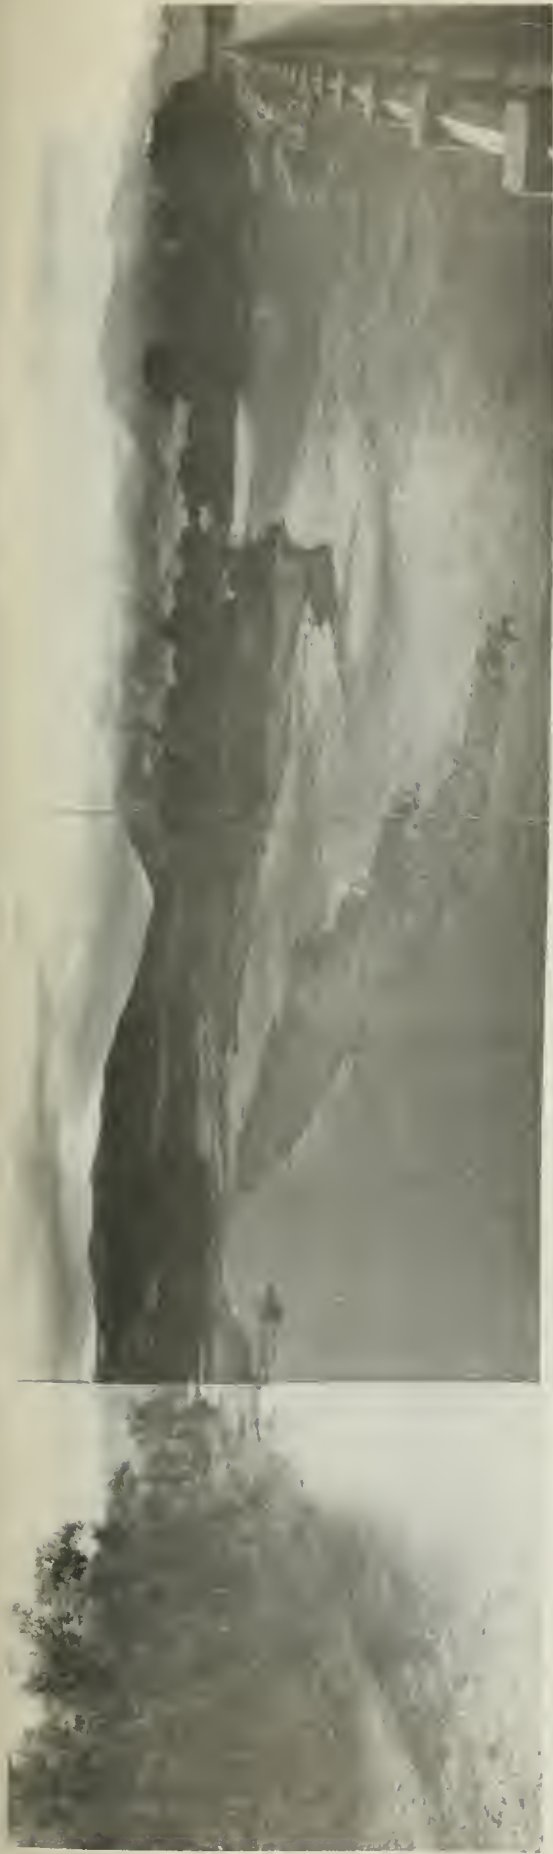
Figure 7. Looking upstream from the U.S. Highway 10 bridge (reference point 22). September 1974.

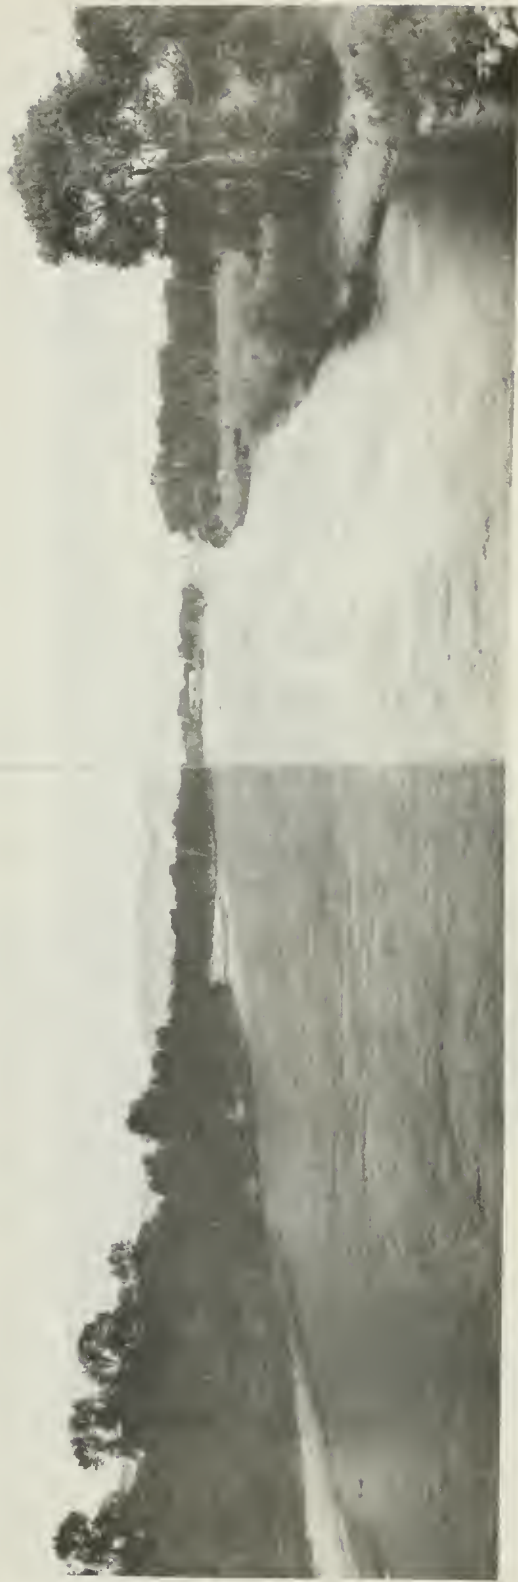
Figure 8. Looking downstream from the Burlington Northern Railroad bridge (reference point 23). September 1974.

the flood of June 1974, the Burlington Northern Railroad bridge (Reference point 23) sustained damage when the large floodflow passing through the bridge caused the south portion of the middle bridge pier to crack and settle.

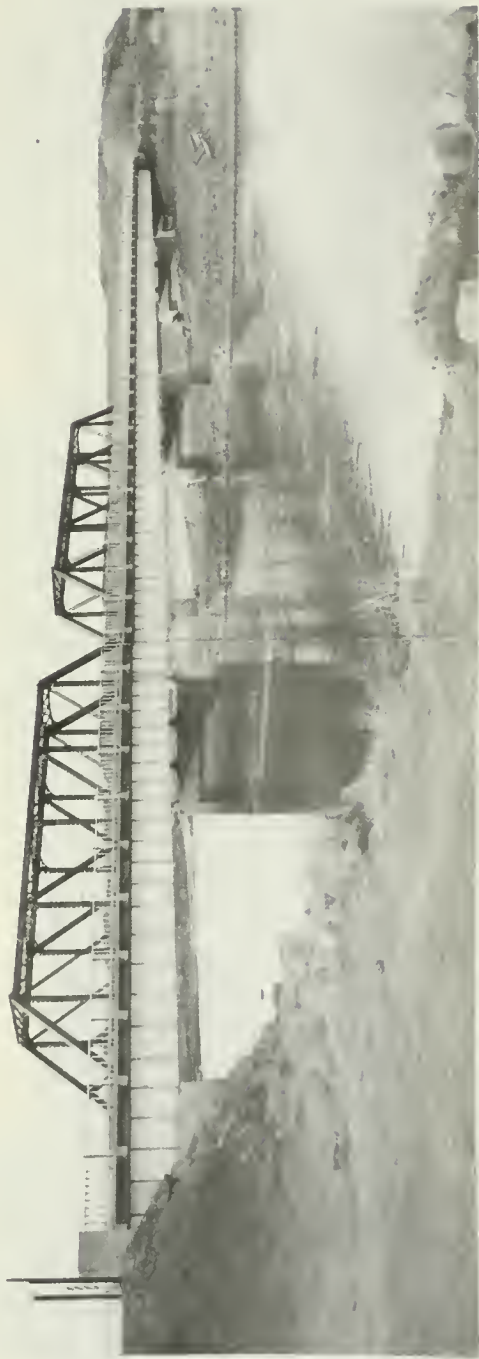
Figure 9. Looking upstream at the U.S. Highway 89 bridge and the Burlington Northern Railroad bridge (reference points 30 and 29 respectively). February 1974.

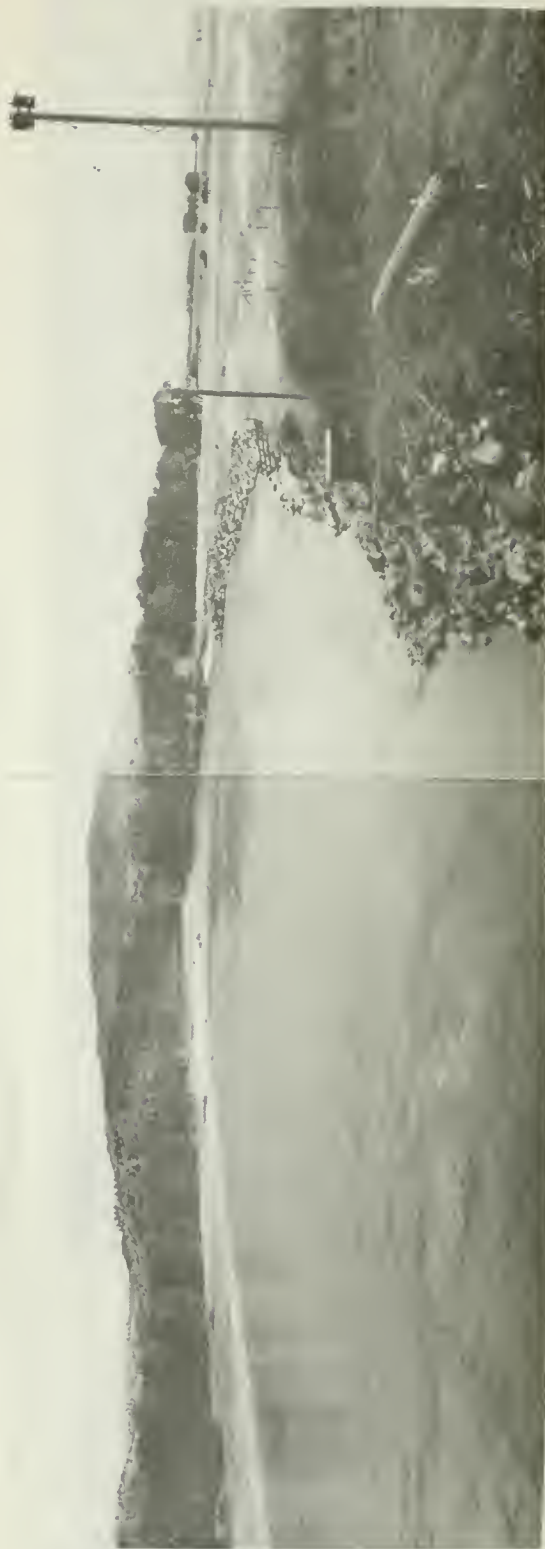
Figure 10. Looking downstream from the U.S. Highway 89 bridge (reference point 30). September 1974.

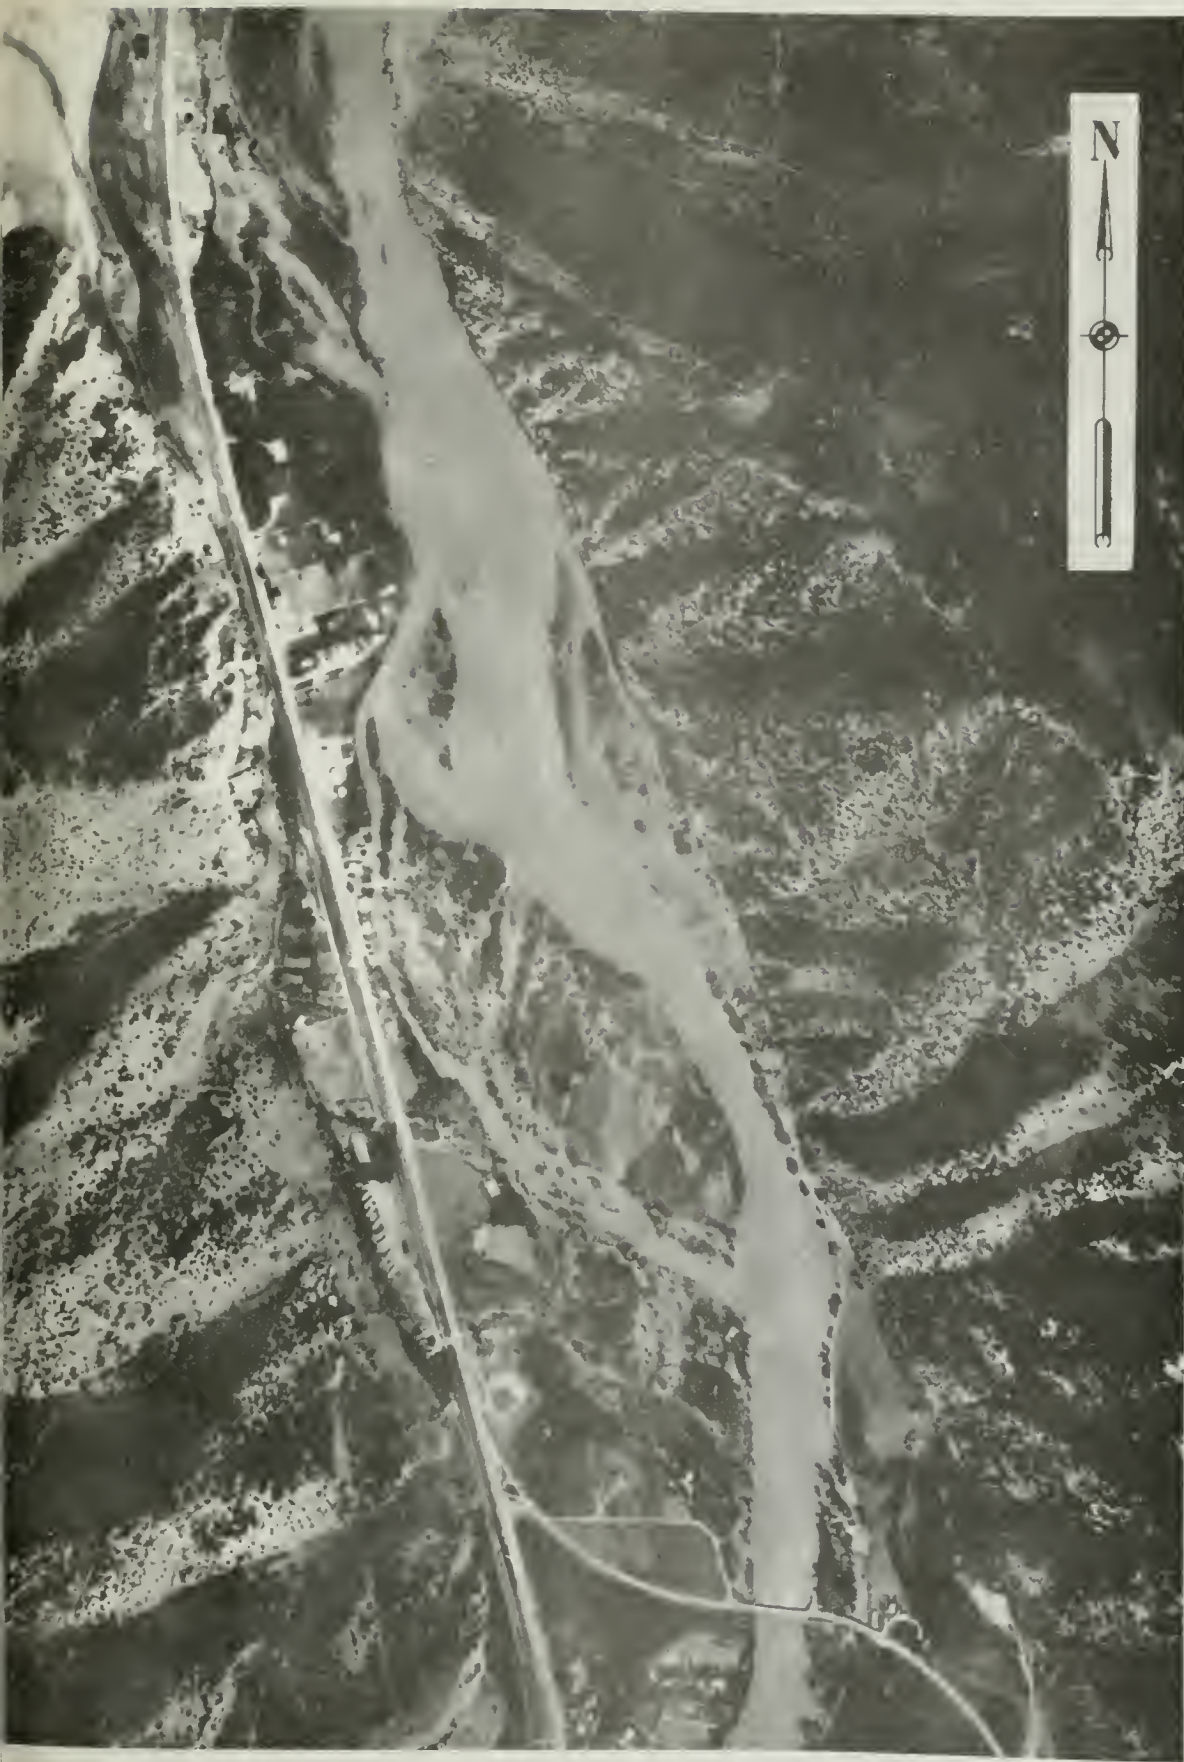
Figure 11. Yellowstone River in the vicinity of Livingston, Montana. The Carter Bridge (reference point 5) is in the southeast corner of the photograph.

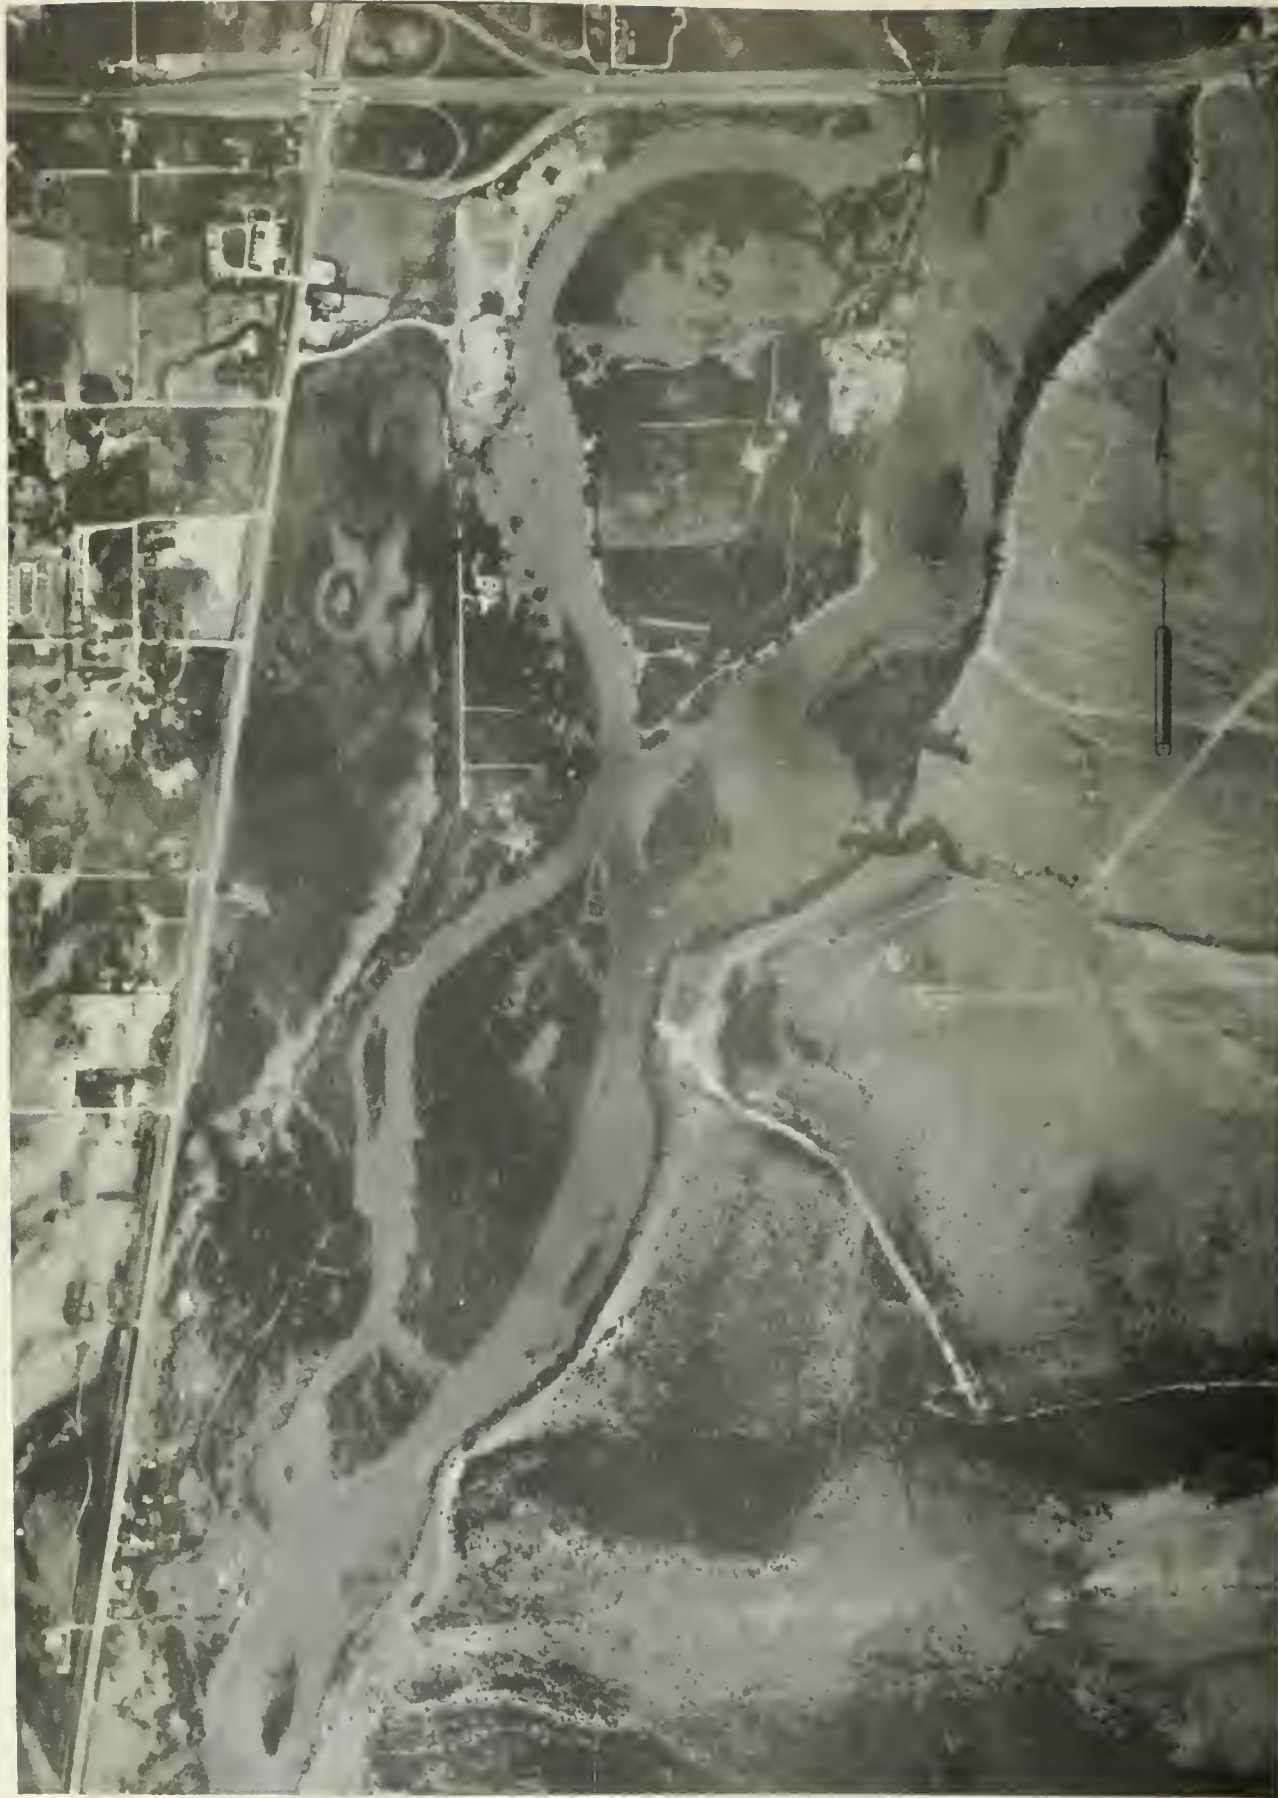
Figure 12. Yellowstone River in the vicinity of Livingston, Montana. Interstate 90 is at the extreme north

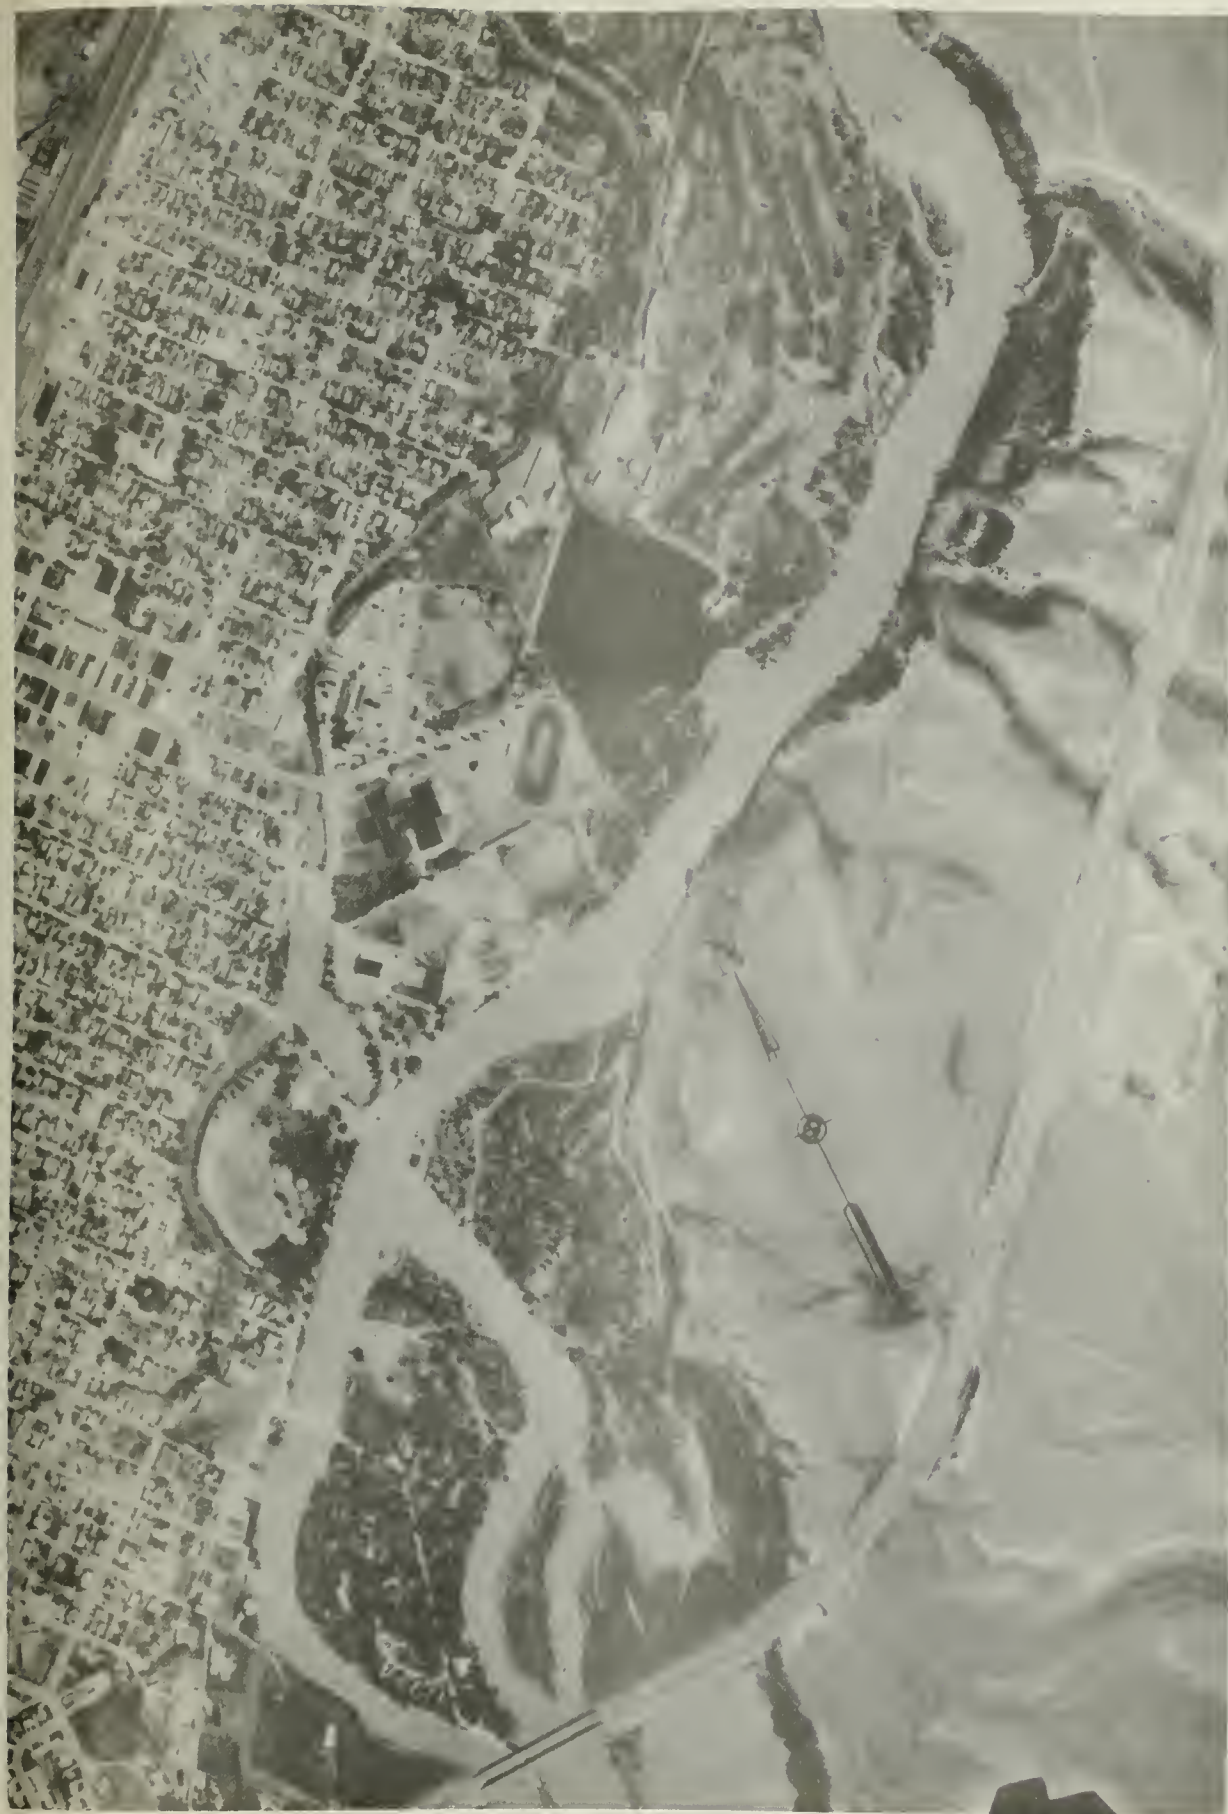
Figure 13. Yellowstone River in the vicinity of Livingston, Montana. The Interstate 90 bridge over the Yellowstone River is at the extreme south edge of this photograph. The south edge of this photograph overlaps the north edge of the photograph of Figure 12.

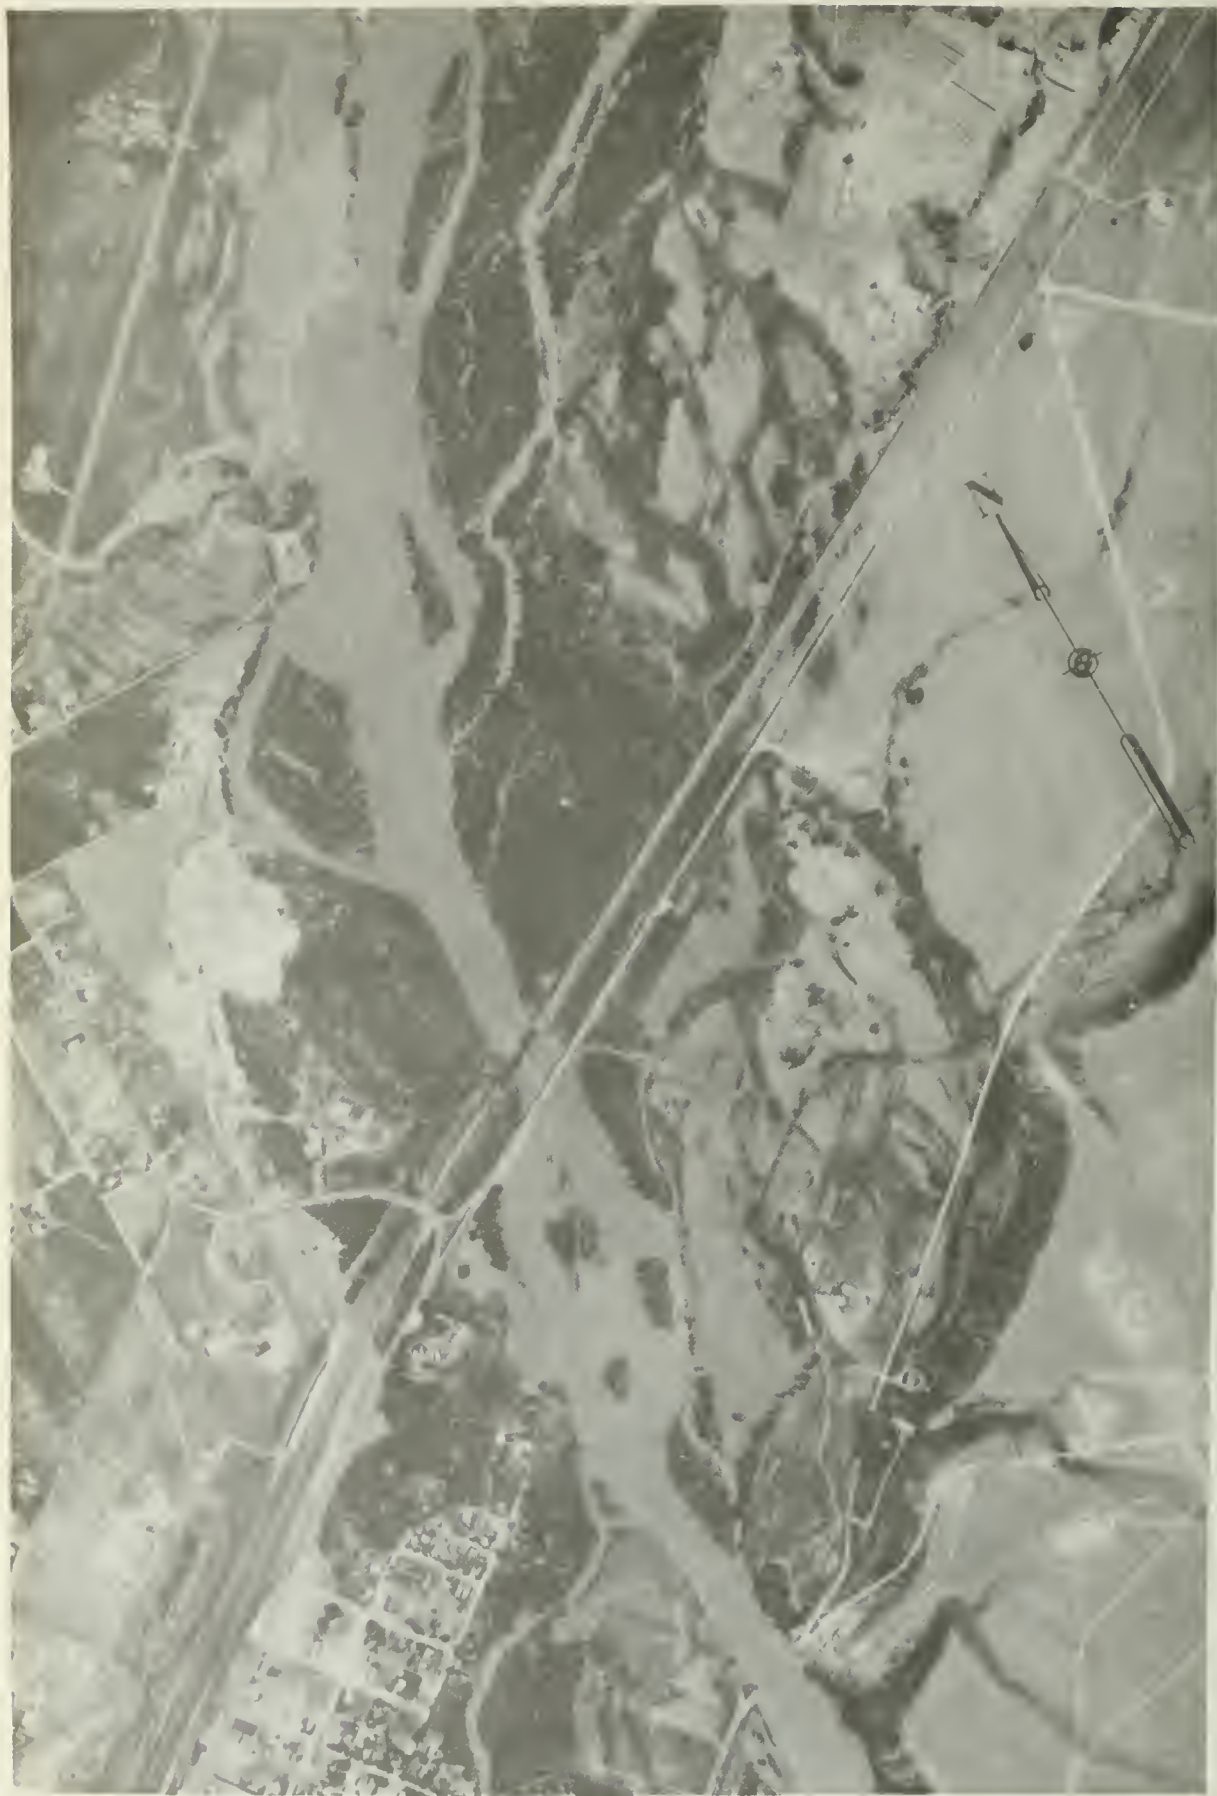
Figure 14. Yellowstone River in the vicinity of Livingston, Montana. The Burlington Northern Inc. bridge and the U.S. Highway 10 bridge over the Yellowstone River are shown in the center of the photo. The south edge of this photograph matches the north edge of the photograph of Figure 13.

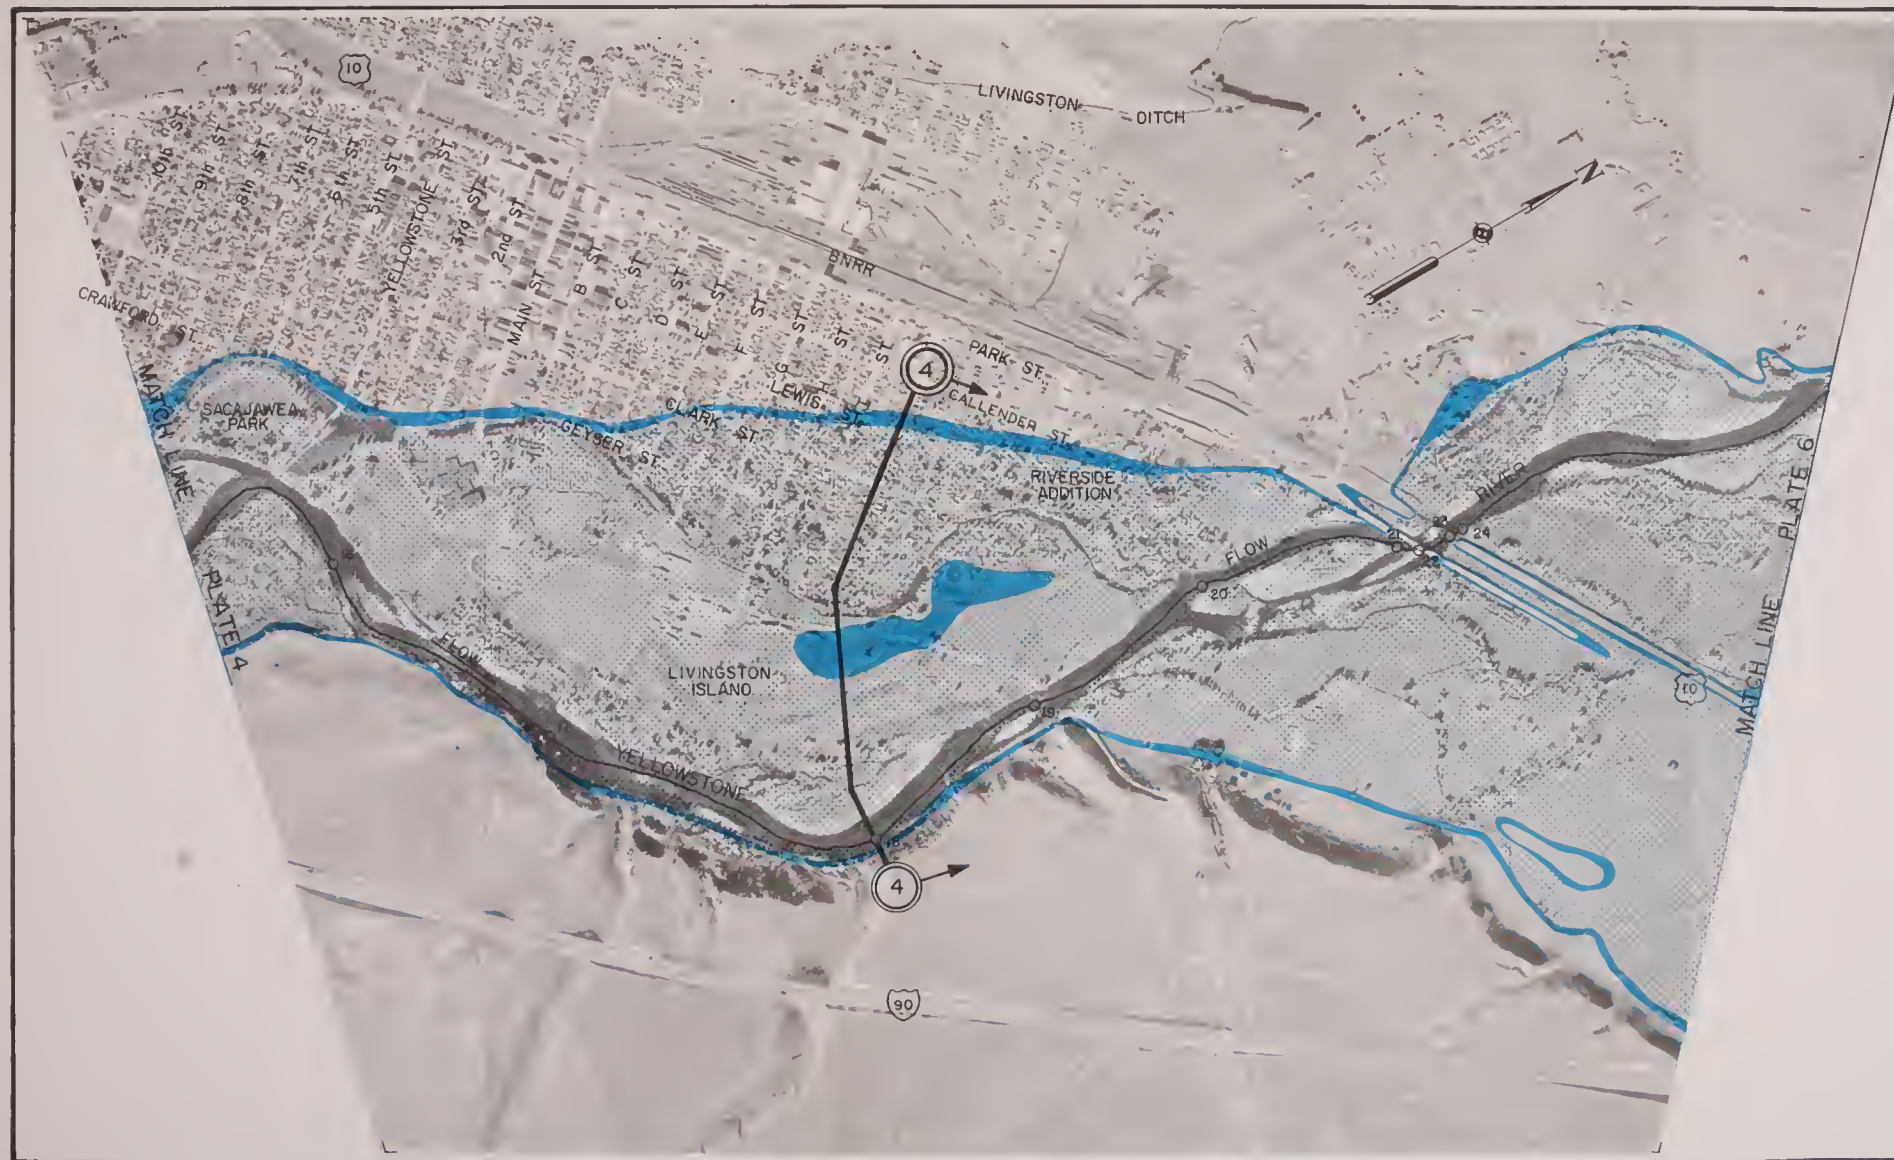
YELLOWSTONE RIVER BASIN
 LIVINGSTON, MONTANA
**YELLOWSTONE RIVER
 FLOODED AREAS**
 U. S. ARMY ENGINEER DISTRICT, OMAHA
 CORPS OF ENGINEERS OMAHA, NEBRASKA
 NOVEMBER 1974

Flooded area and flood damages - Water surface profiles for the Intermediate Regional and Standard Project Floods were developed for the study reach using the backwater computer program HEC-2, "Water Surface Profiles" developed by the U.S. Army Corps of Engineers. The computations were based on channel and flood plain conditions as represented by surveys conducted in the summer of 1973 and as supplemented by later field investigations.
